School District 85

Seaview Carpentry Shop 901 Marine Drive, Port Alice, BC Asbestos Management Inventory

NWest File: 39957 AMI1 V1.0
Date Issued: November 16, 2020

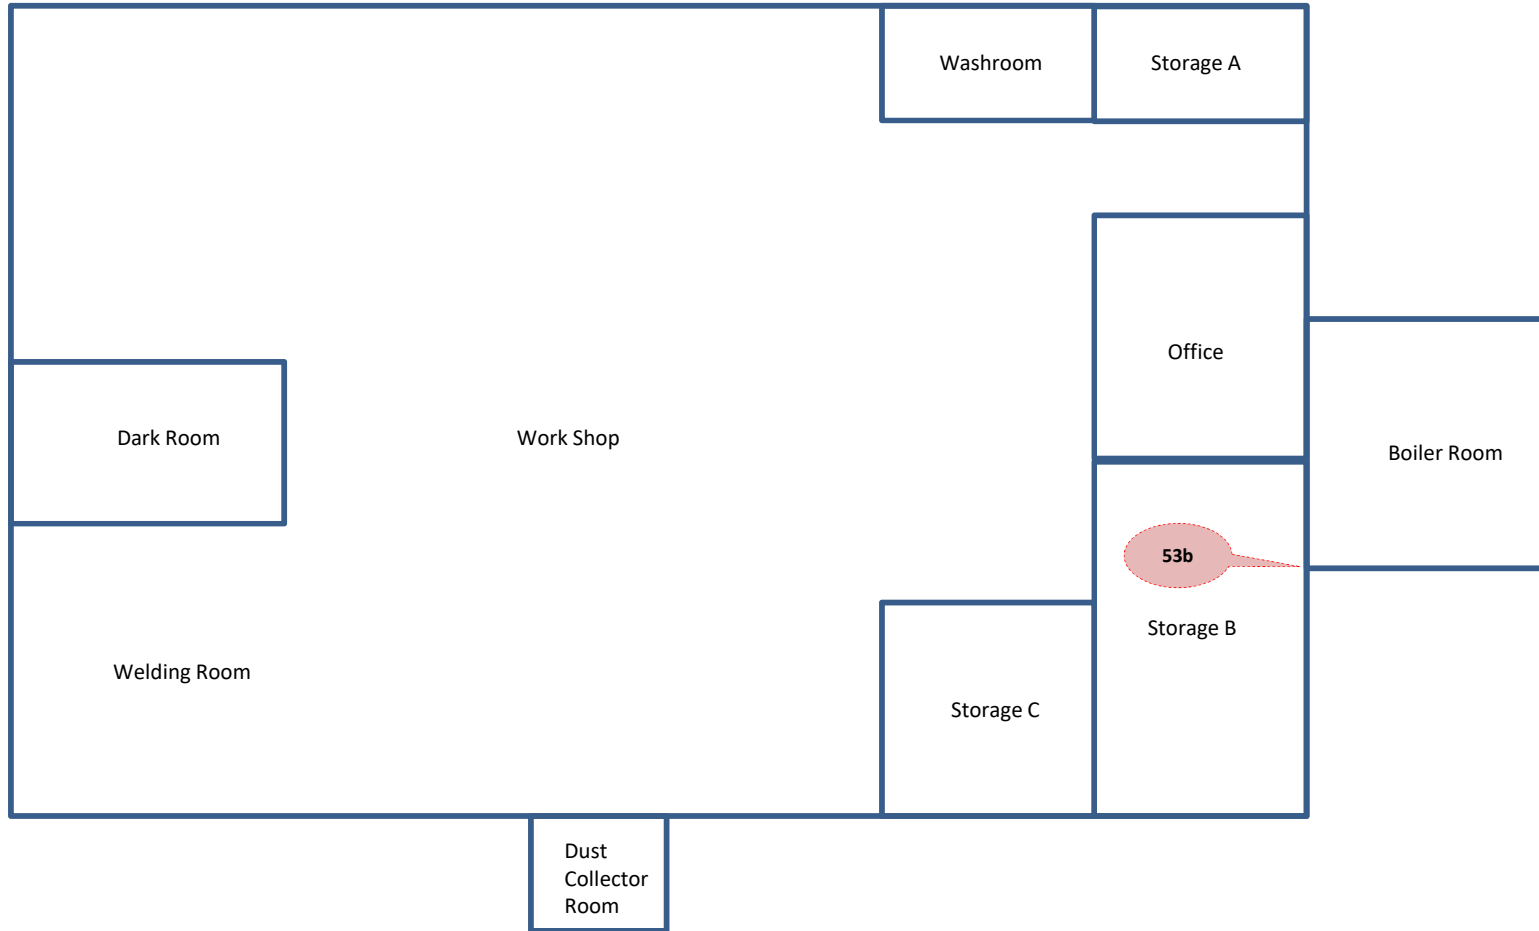
Location: Seaview Carpentry Shop, 901 Marine Drive, Port Alice, BC
Drawing Title: Sample Locations
Project No: 39957
Drawing No: 001
Surveyed By: PG
Survey Date: August 27, 2020

53b Vermiculite
