## School District 85

### Seaview Activity Centre 901 Marine Drive, Port Alice, BC Asbestos Management Inventory

NWest File: 39957 AMI1 V1.0  
Date Issued: November 16, 2020

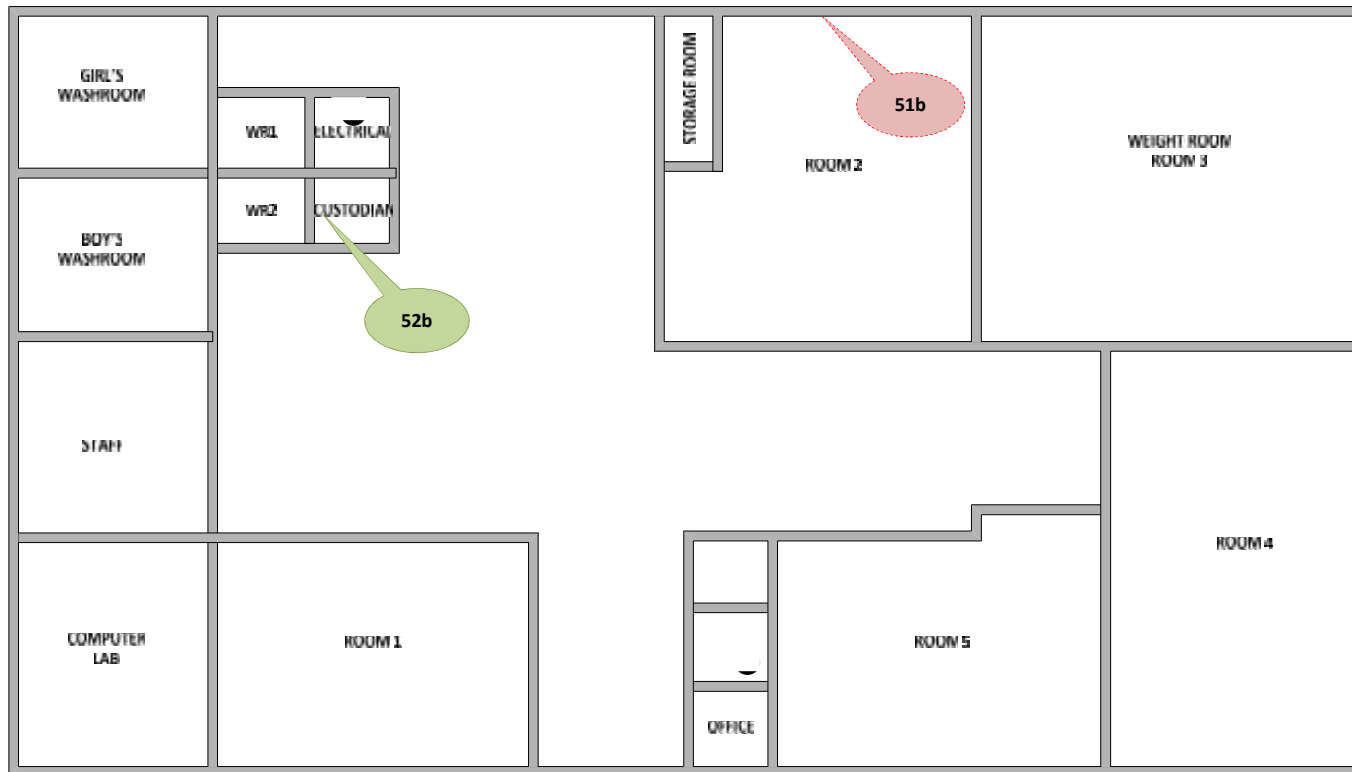
**Location:** Seaview Activity Centre,  
 901 Marine Drive, Port Alice, BC  
**Drawing Title:** Sample Locations  
**Project No:** 39957  
**Drawing No:** 001  
**Surveyed By:** PG & LK  
**Survey Date:** August 27, 2020

51b	Window putty (Black)
52b	Pipe wrap with black mastic
