## School District 85

### **Maintenance Shop Building 2 2071 McNeill Road, Port McNeill, BC Asbestos Management Inventory**

NWest File: 39957 AMI1 V1.0

Date Issued: January 4, 2021

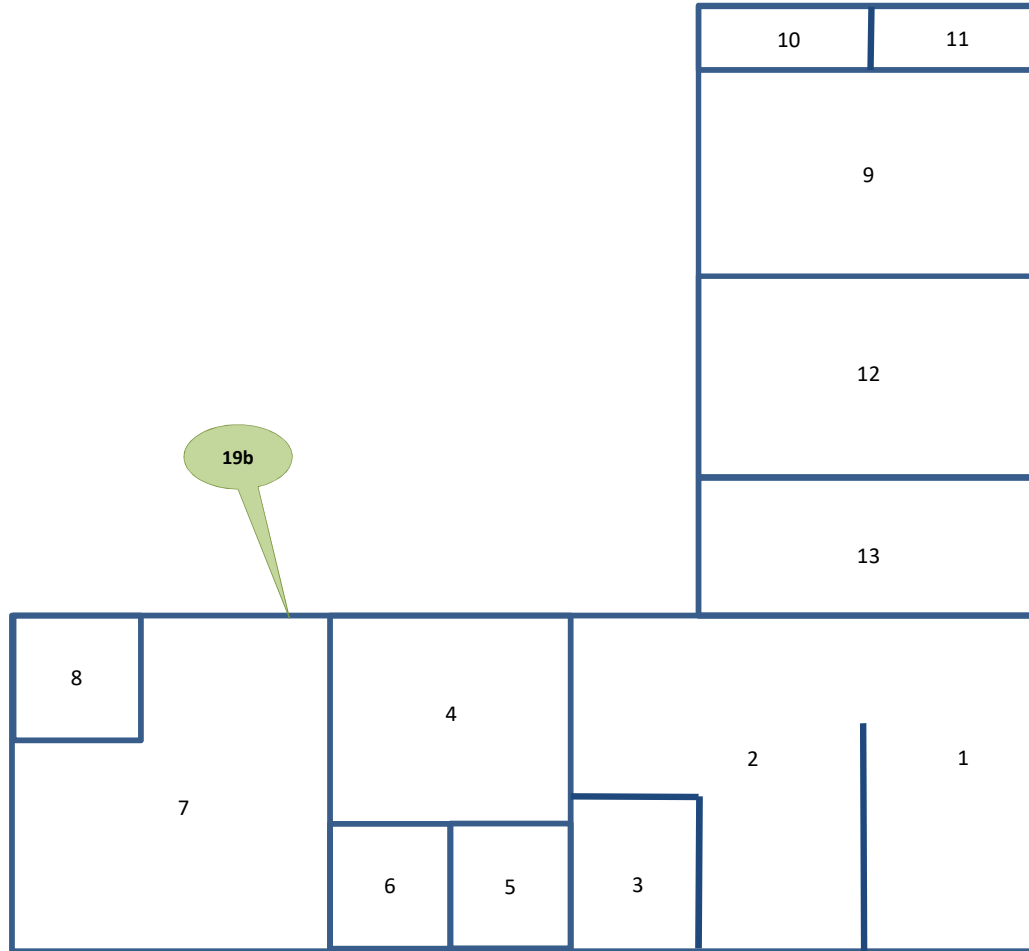
**Location:** Maintenance Shop  
Building 2, 2071 McNeill Road,  
Port McNeill, BC  
**Drawing Title:** Sample Locations  
**Project No:** 39957  
**Drawing No:** 001  
**Surveyed By:** PG & LK  
**Survey Date:** August 18, 2020

**19b** Aggregate Panel Beneath Window
