School District 85

Maintenance Shop Building 1 2071 McNeill Road, Port McNeill, BC Asbestos Management Inventory

NWest File: 39957 AMI1 V1.0

Date Issued: January 4, 2021

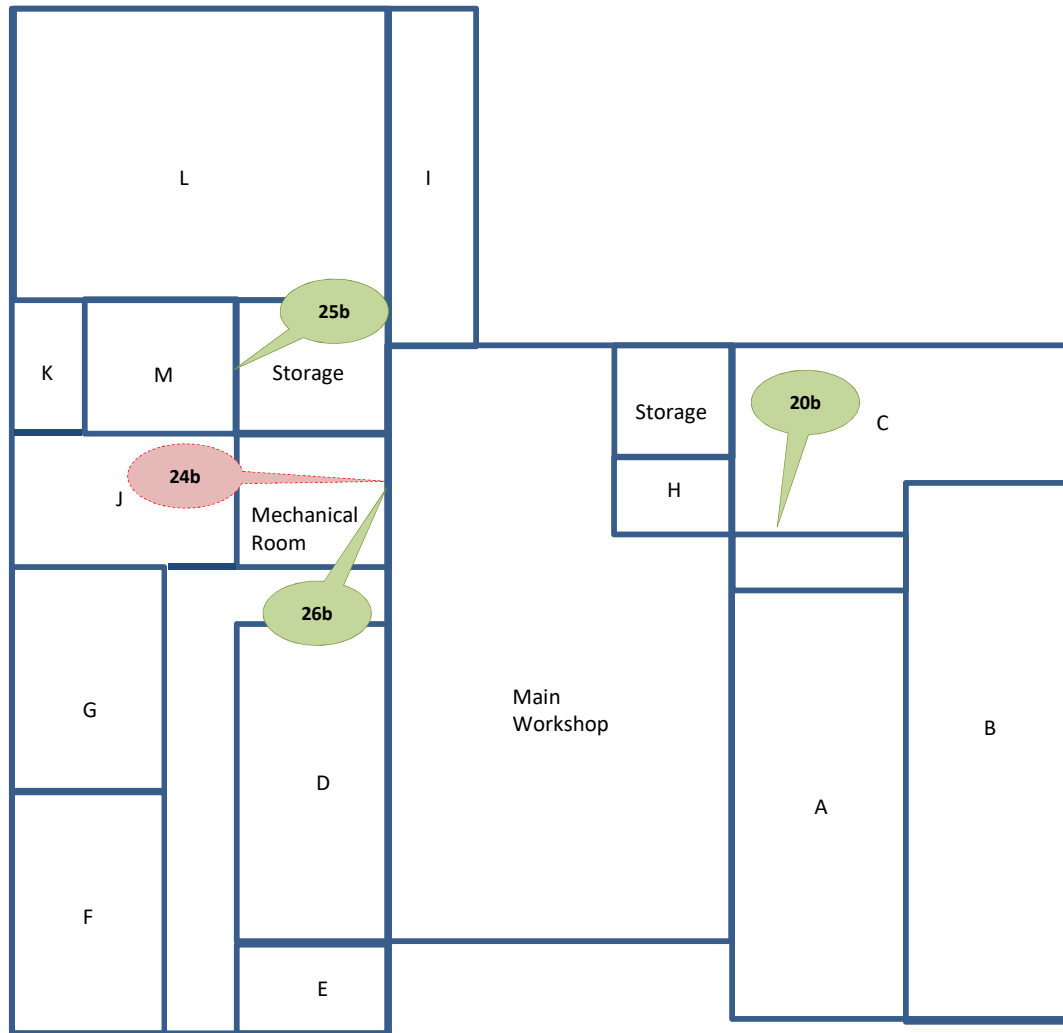
Location: Maintenance Shop
Building 1, 2071 McNeill Road,
Port McNeill, BC
Drawing Title: Sample Locations
Project No: 39957
Drawing No: 001
Surveyed By: PG & LK
Survey Date: August 18, 2020

20b	Floor Tile 1 – 9”x9” Grey with White Streaks
24b	Drywall Joint Compound
25b	Drywall Joint Compound
26b	Floor Tile (Unknown Pattern) Under Plywood
