Port Hardy Secondary School
9350 Granville Street, Port Hardy, BC
Asbestos Management Inventory

North West
Environmental Group Ltd.

NWest File: 39957 AMI1 V1.0

Date Issued: May 4, 2021

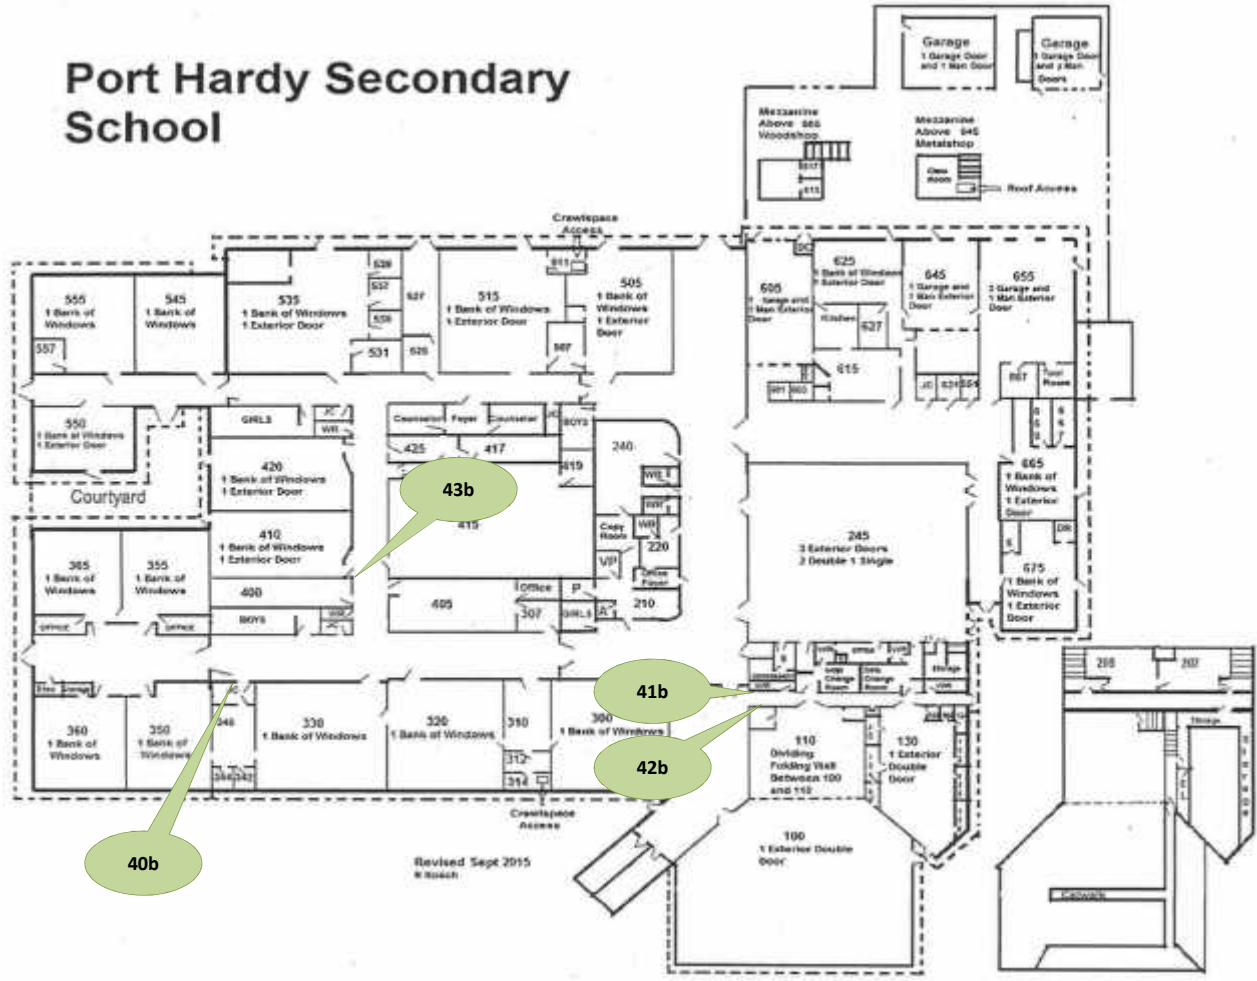
Location: Port Hardy Secondary School, 9350 Granville Street, Port Hardy, BC
Drawing Title: Sample Locations
Project No: 39957
Drawing No: 001
Surveyed By: PG & LK
Survey Date: August 25, 2020

40b	Drywall joint compound
41b	Stair tread – red
42b	Baseboard adhesive
43b	Baseboard adhesive

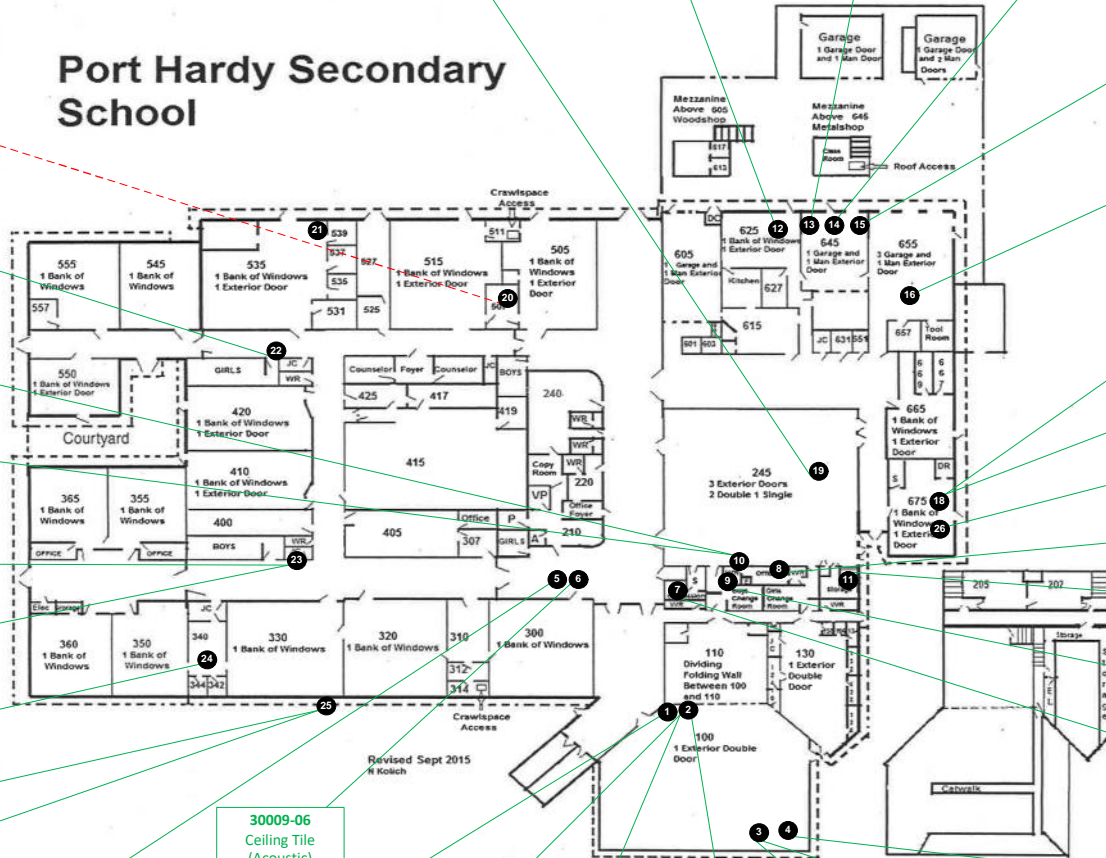
30009-21
Mastic – Mastic
Black around Exterior Vent

30009-20
Mastic – Sink Mastic
Black
