School District 85

Woss Elementary
4500 MacRae Drive, Woss, BC
Asbestos Management Inventory

NWest File: 39957 AMI1 V1.0
Date Issued: April 20, 2021

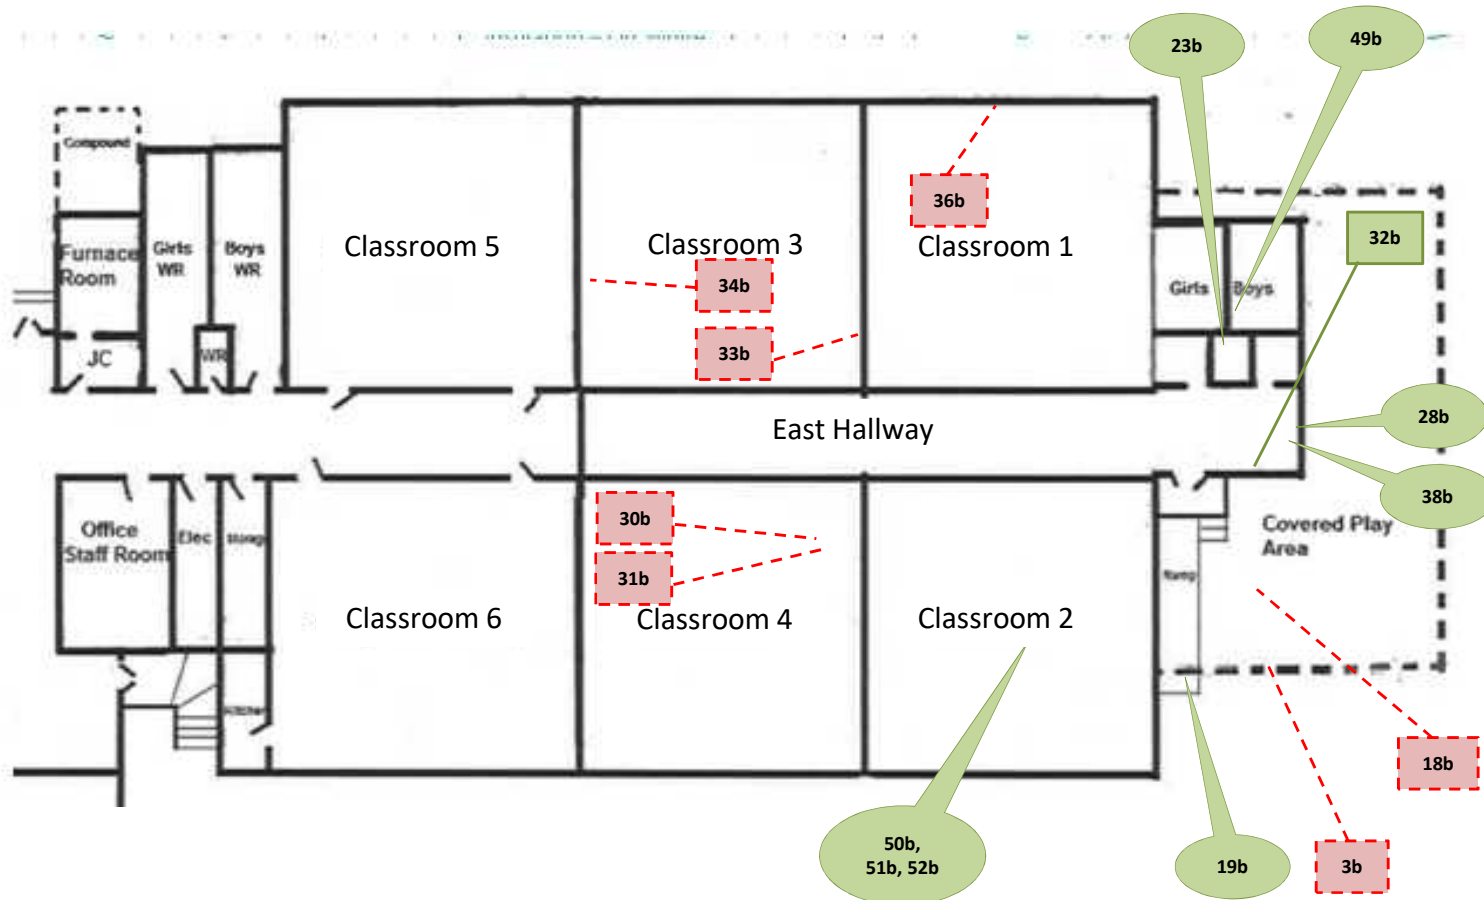
Location: 4500 McRae Drive, Woss, BC
Drawing Title: East Wing Sample Locations
Project No: 39956
Drawing No: 001
Surveyed By: PG & LK
Survey Date: August 11, 2020

| 3b | Green paint on metal posts |
| 18b | White paint on ceiling/soffit |

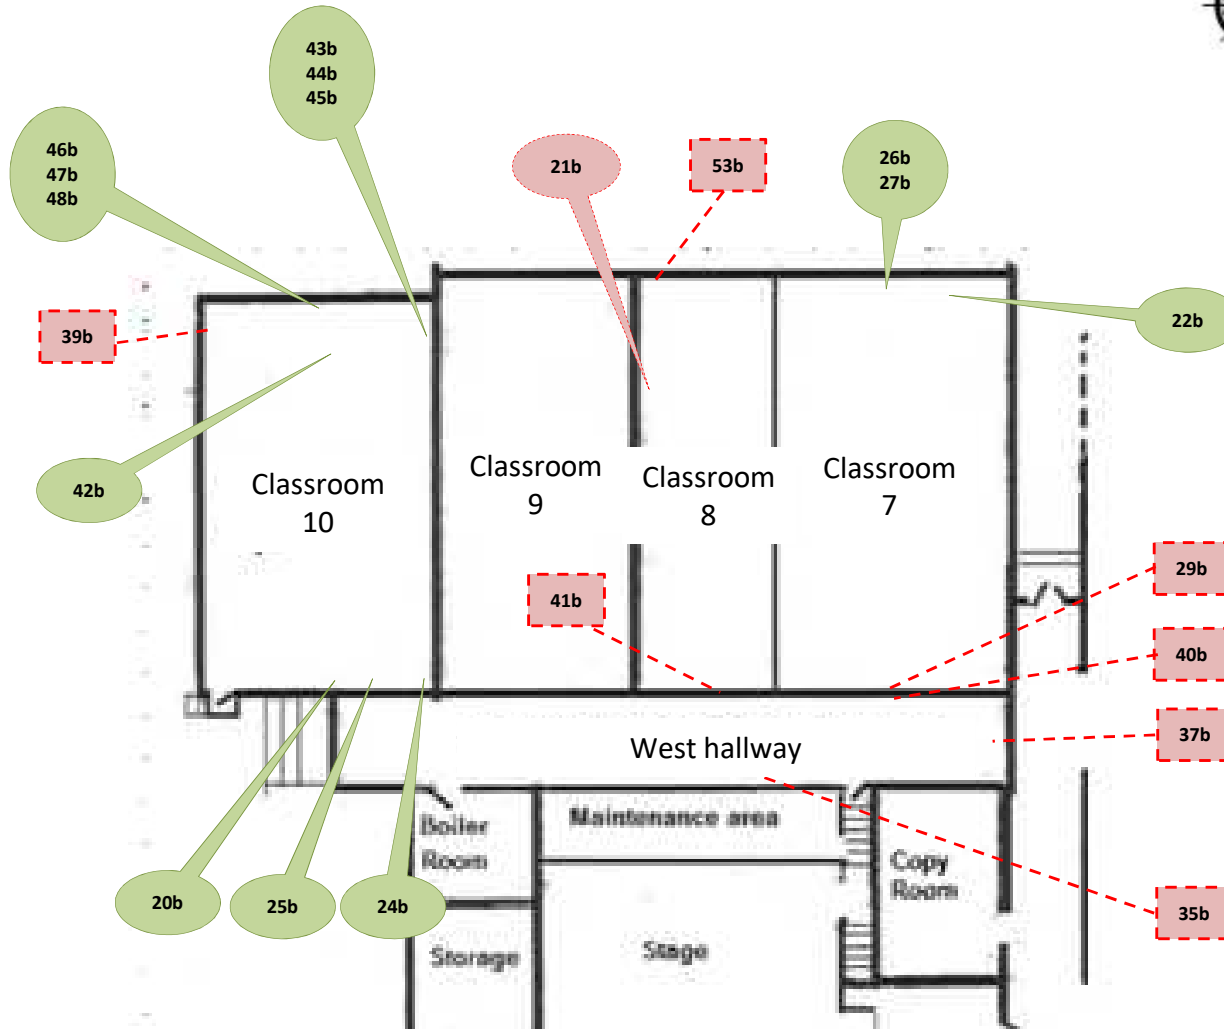
Location: 4500 McRae Drive, Woss, BC
Drawing Title: West Wing Sample Locations
Project No: 39956
Drawing No: 002
Surveyed By: PG & LK
Survey Date: August 11, 2020

| 20b | Pipe mud (white) |

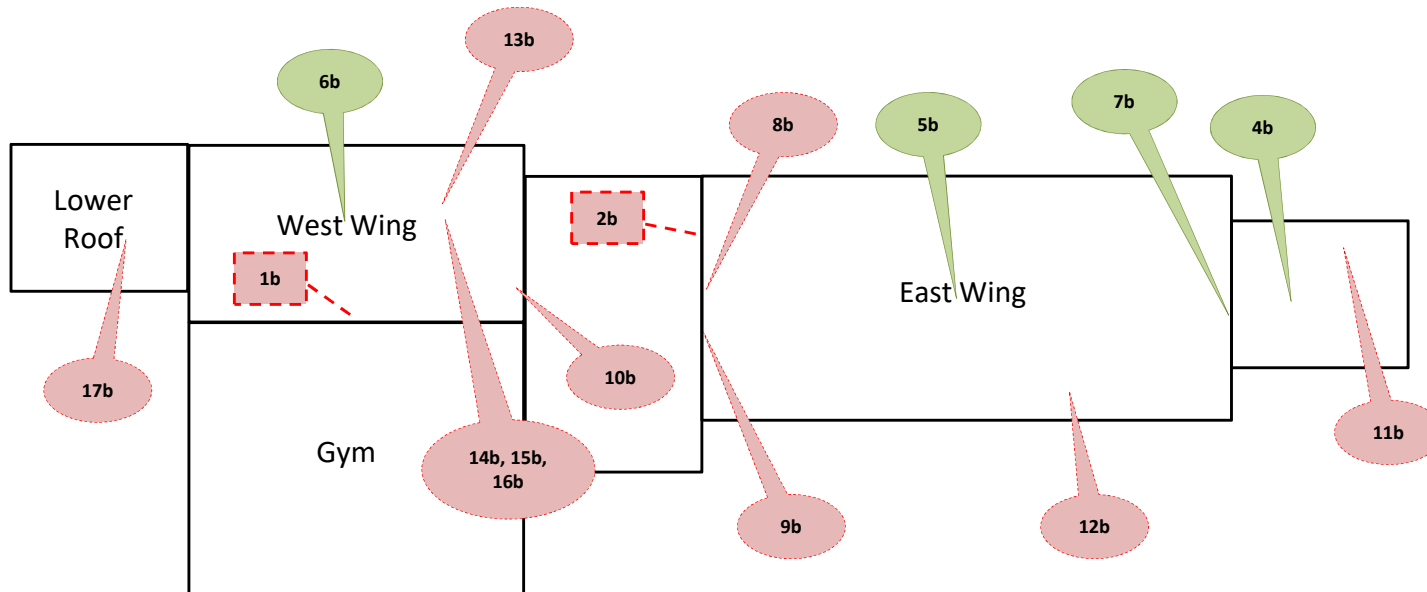
Location: 4500 McRae Drive, Woss, BC
Drawing Title: Roof Sample Locations
Project No: 39956
Drawing No: 003
Surveyed By: PG & LK
Survey Date: August 11, 2020

| 1b | Light grey paint on wood |
| 2b | Brown paint on wood |
